# Update of Cooperative Projects in WV Eastern Panhandle

- Berkeley County Water Resources Assessment and Fracture-Trace Analysis
- Jefferson County Water Resources Assessment and Fracture-Trace Analysis
- Morgan County Water Resources and Water Quality Assessment

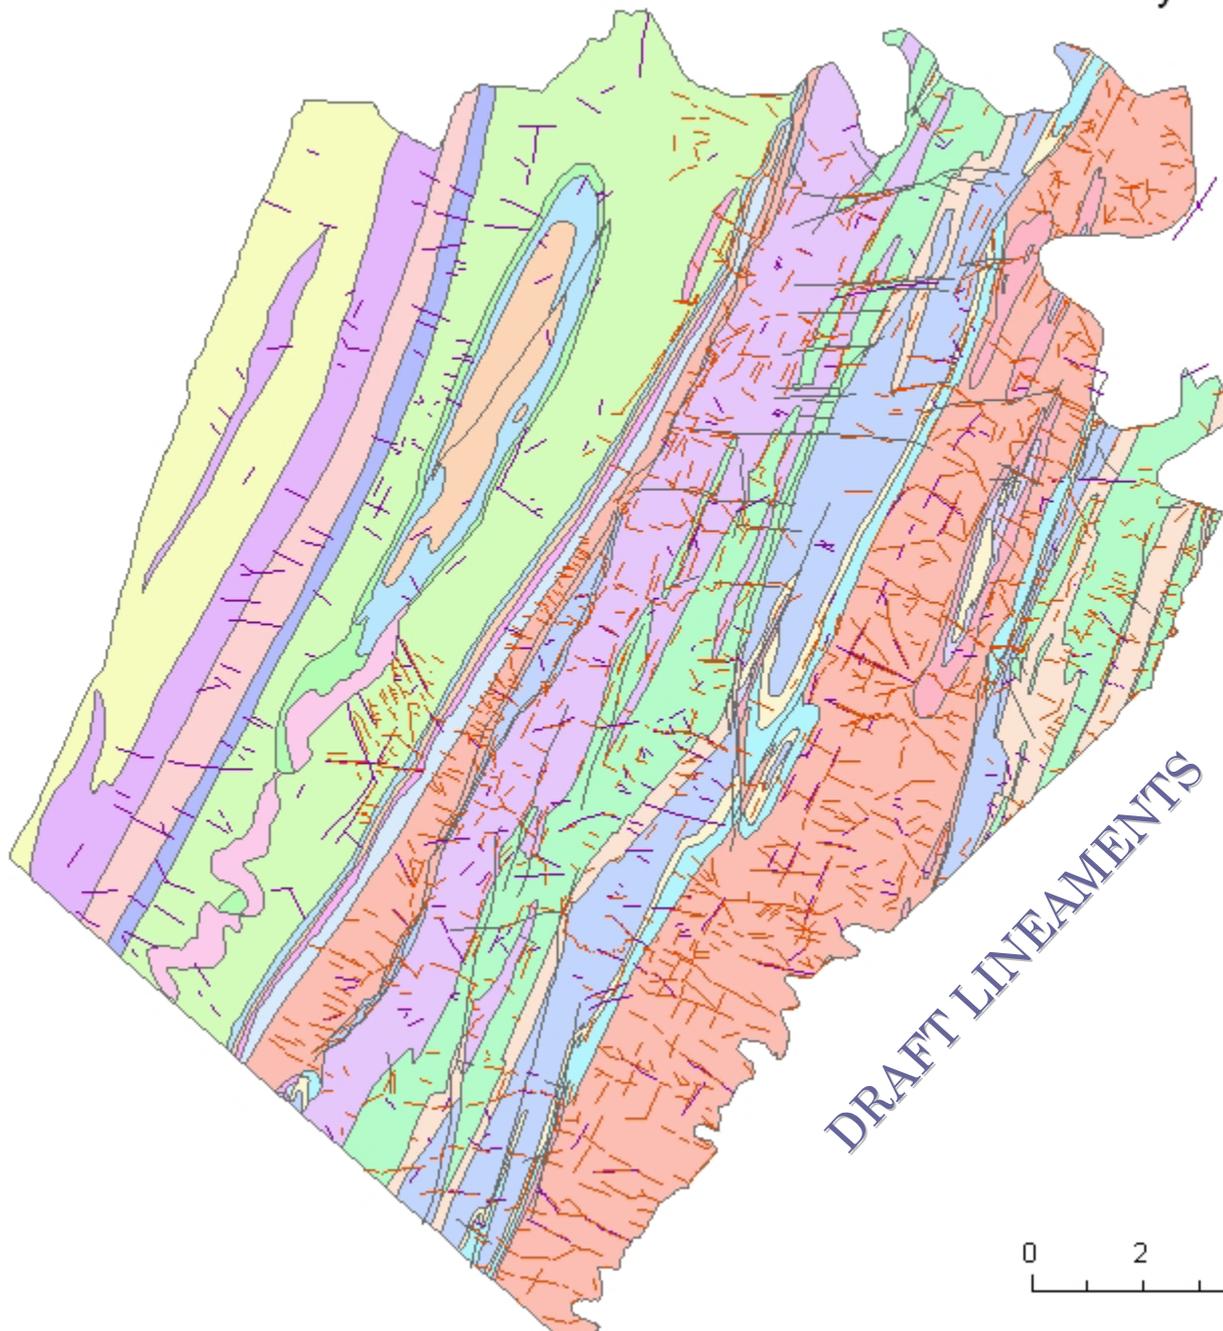
# Preliminary Lineaments mapped by the USGS in Berkeley County in 2003

**DRAFT LINEAMENTS**

## EXPLANATION

USGS Lineaments
-

Fractures from Hobba
-

Faults from 1968 Geology of WV

## Geology of Berkeley County

- Fracture-trace delineation complete
- Aquifer characterization
  - Field work—200 pumping tests completed
  - Data analysis and interpretation is ongoing
  - Report being drafted
